# **INDOOR AIR QUALITY ASSESSMENT**

**Lynnhurst Elementary School  
Walnut Street  
Saugus, Massachusetts**

Prepared by:  
Massachusetts Department of Public Health  
Bureau of Environmental Health Assessment  
Emergency Response/Indoor Air Quality Program  
January 2003

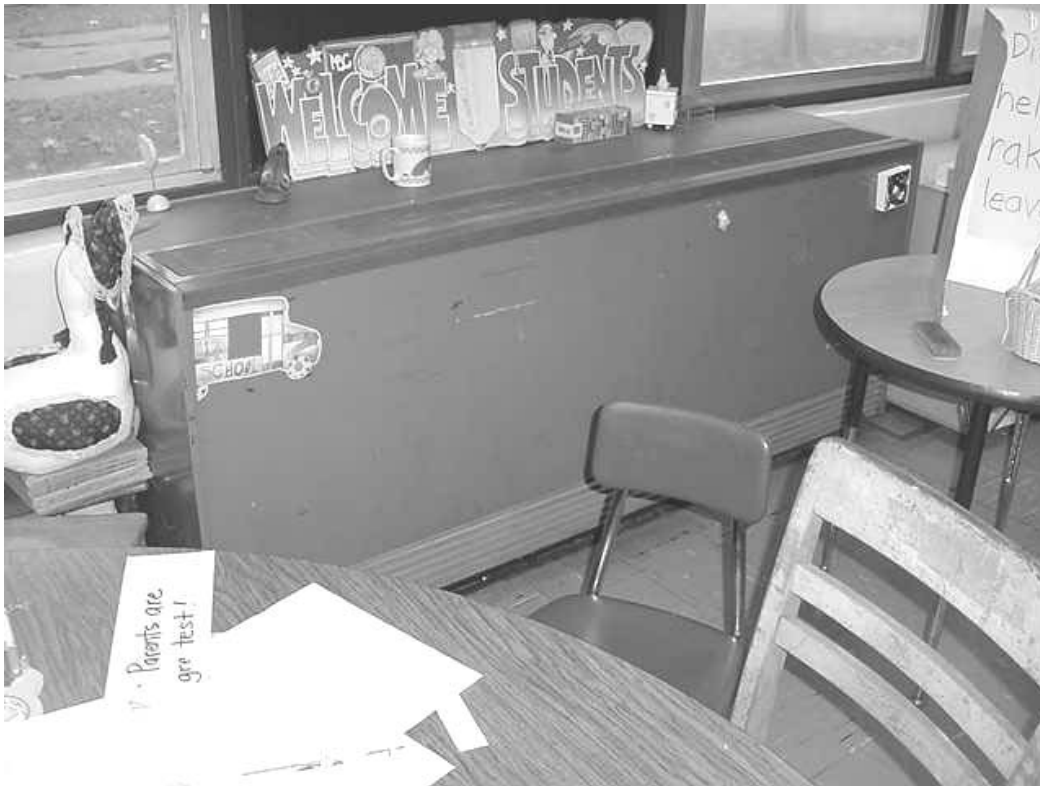
**Picture 1**

Fresh air in classrooms is supplied by a unit ventilator (univent) system (see Picture 1). Univents draw air from outdoors through a fresh air intake located on the exterior walls of the building (see Picture 2) and return air through an air intake located at the base of each unit (see [Figure 1](#)). Fresh and return air are mixed, filtered, heated and provided to classrooms through a fresh air diffuser located in the top of the unit. Univents appear to be original equipment. The majority of univents were not operating during the assessment due to mechanical problems with the thermostats/pneumatic system. Mr. Nigro reported that this problem was in the process of being addressed by an HVAC engineering firm who had a representative present in the building during the assessment. Obstructions to airflow, such as papers and books stored on univents and items in front of univent returns were seen in a number of classrooms (see Picture 3). In order for univents to provide fresh air as designed, intakes must remain free of obstructions. Importantly, these units must remain “on” and allowed to operate while these rooms are occupied.

**Typical Classroom Univent**

1. Continue to work with HVAC engineer to repair the ventilation control system. Have engineer survey classrooms for univent function to ascertain if an adequate air supply exists for each room. Consider having univent fresh air control dampers calibrated school-wide.

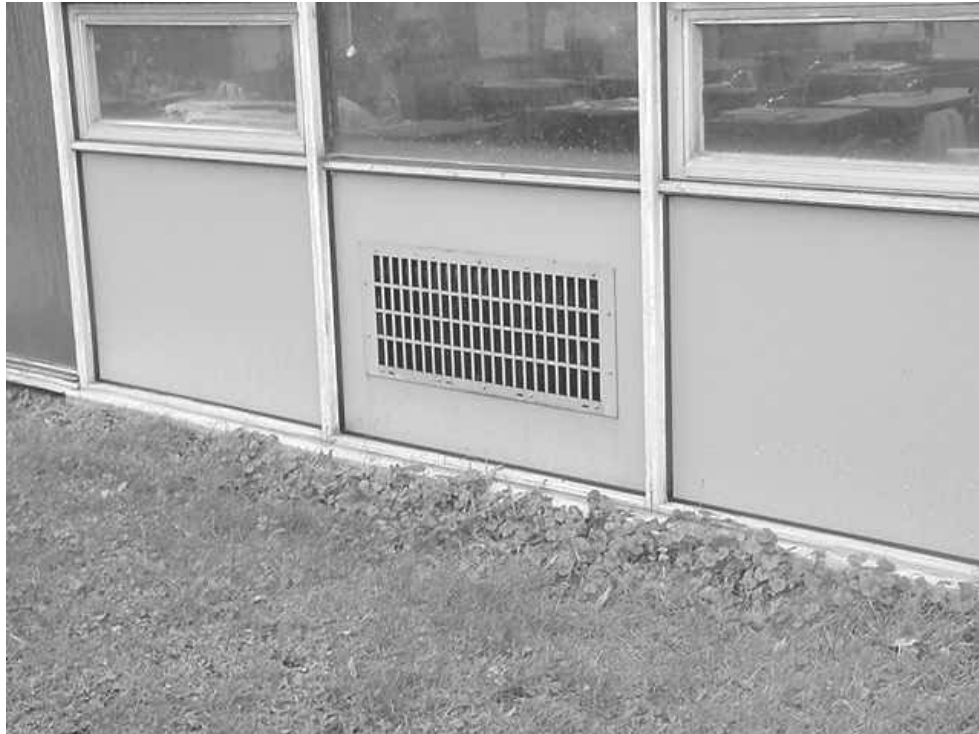
**Picture 2**

**Univent Outside Air Intake**

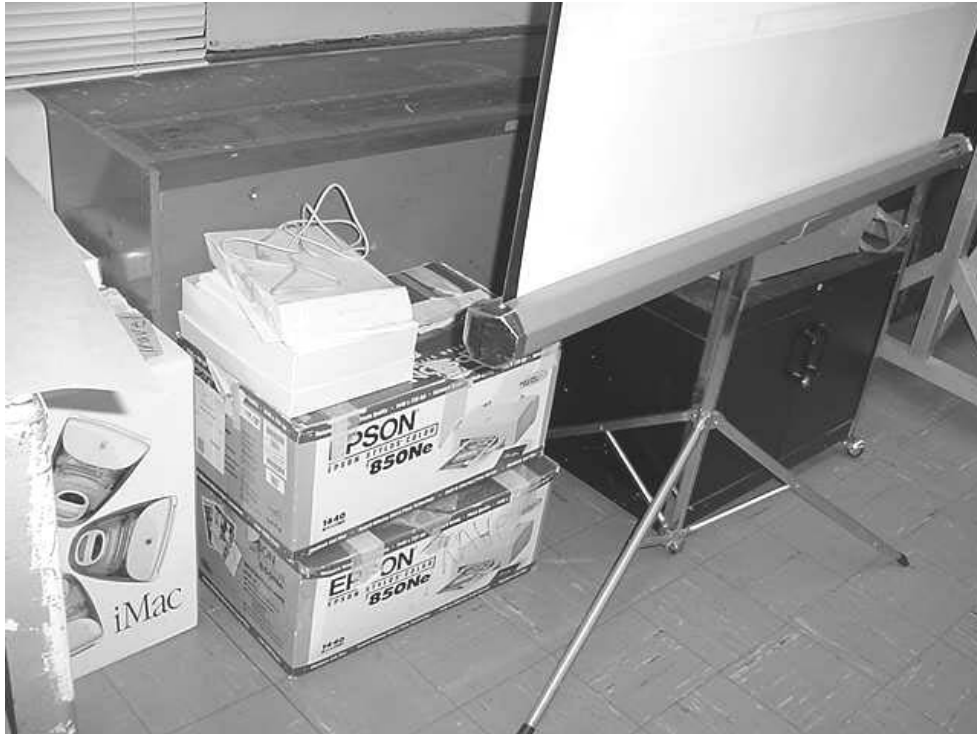
**Picture 3**

**Univent Return Vent (bottom) Obstructed by Various Items**

2. Inspect rooftop exhaust motors and belts for proper function, repair and replace as necessary.
3. Remove all blockages from univents and exhaust vents. Clean out interiors of univents regularly (e.g. with filter changes).

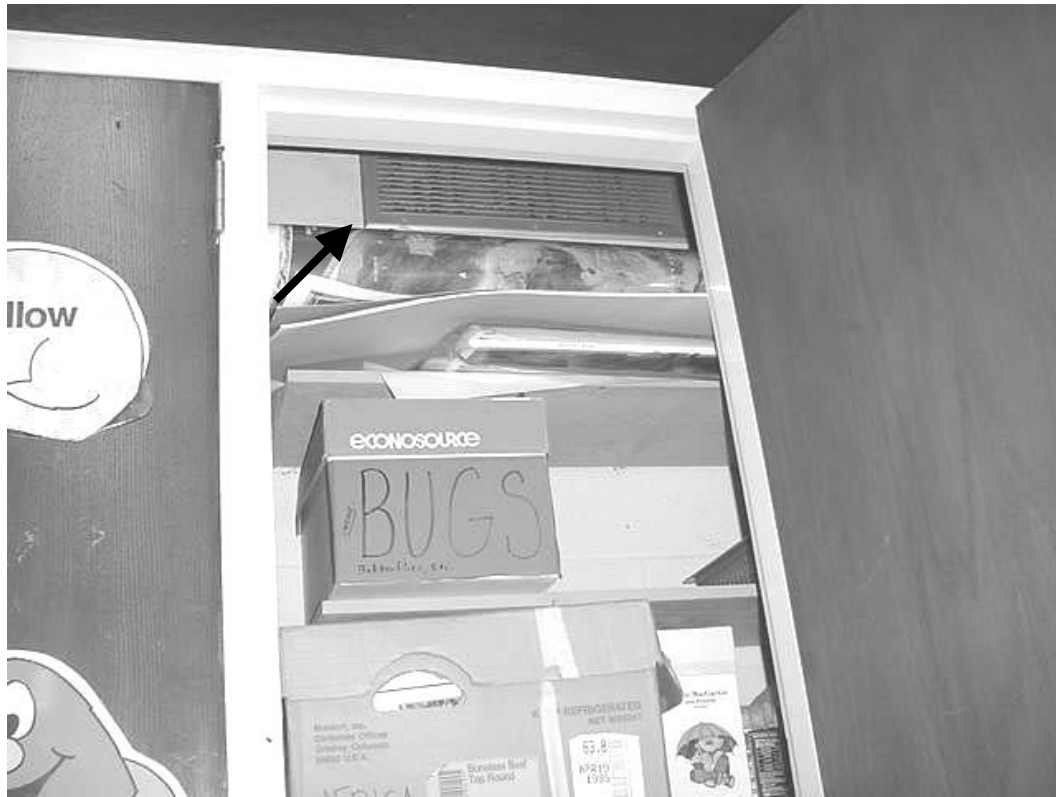
**Picture 4**

Exhaust ventilation in classrooms consists of grilles located in the ceiling of coat closets (see Picture 4), which are powered by rooftop motors. Air is drawn into the coat closet from the classroom via undercut closet doors (see Picture 5). This exhaust system was either not functioning or drawing weakly in a number of the areas surveyed, indicating the motors were deactivated or non-functional. BEHA staff examined exhaust motors on the roof and found several not operating. In addition, the location of these closet vents allows them to be easily blocked by stored materials. Further decreasing airflow was the accumulation of dirt and dust build-up on exhaust vents. As with the univents, in order to function properly, exhaust vents must be activated and remain free of obstructions.

**Classroom Exhaust Vent in Top of Coat Closet**

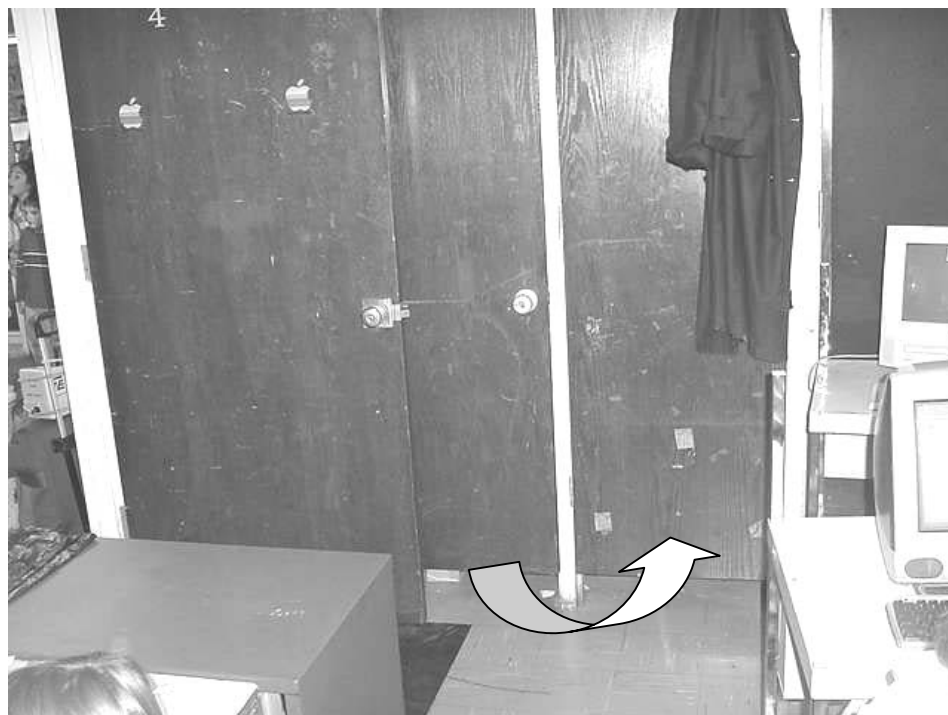
**Picture 5**

**Undercut Coat Closet Doors**

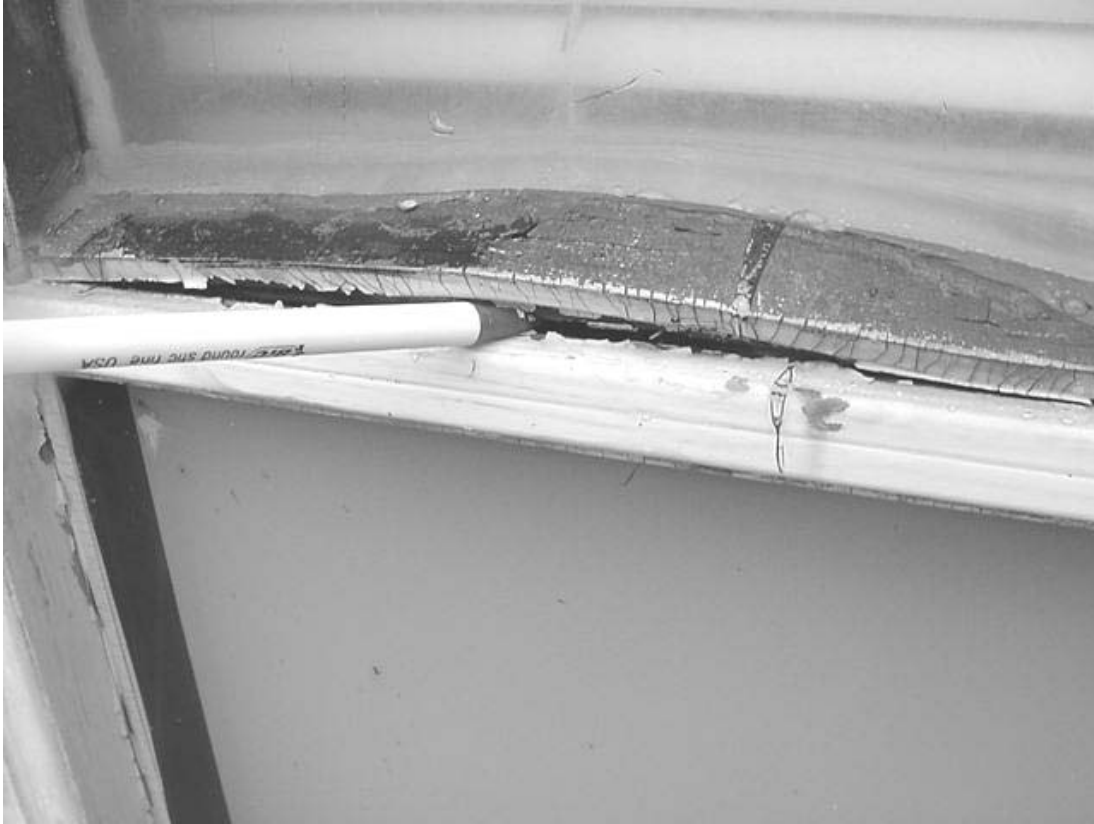
**Picture 6**

Caulking around windows was missing/damaged in many areas (see Picture 6). In some areas attempts were made to reseal windows (see Picture 7). Some of the panes were loose and drafts were evident in many areas. Missing caulking and/or loose fitting window panes can make it difficult to control temperature and allow a means for water penetration into the building, leading to comfort complaints and/or water damage and subsequent microbial growth.

**Exterior Shot of Window Caulking, (Pen Inserted by BEHA staff to Show Scale)**

1. Based on the age, physical deterioration and availability of parts of the HVAC system, the BEHA strongly recommends that an HVAC engineering firm fully evaluate the ventilation system and its control system (e.g. pneumatic controls, air intake louvers, thermostats).
2. Consider consulting a building engineer about possible options to eliminate water pooling on roof.
3. Repair/replace missing or damaged window caulking building-wide to prevent water penetration through window frames. Examine the feasibility of full window replacement.

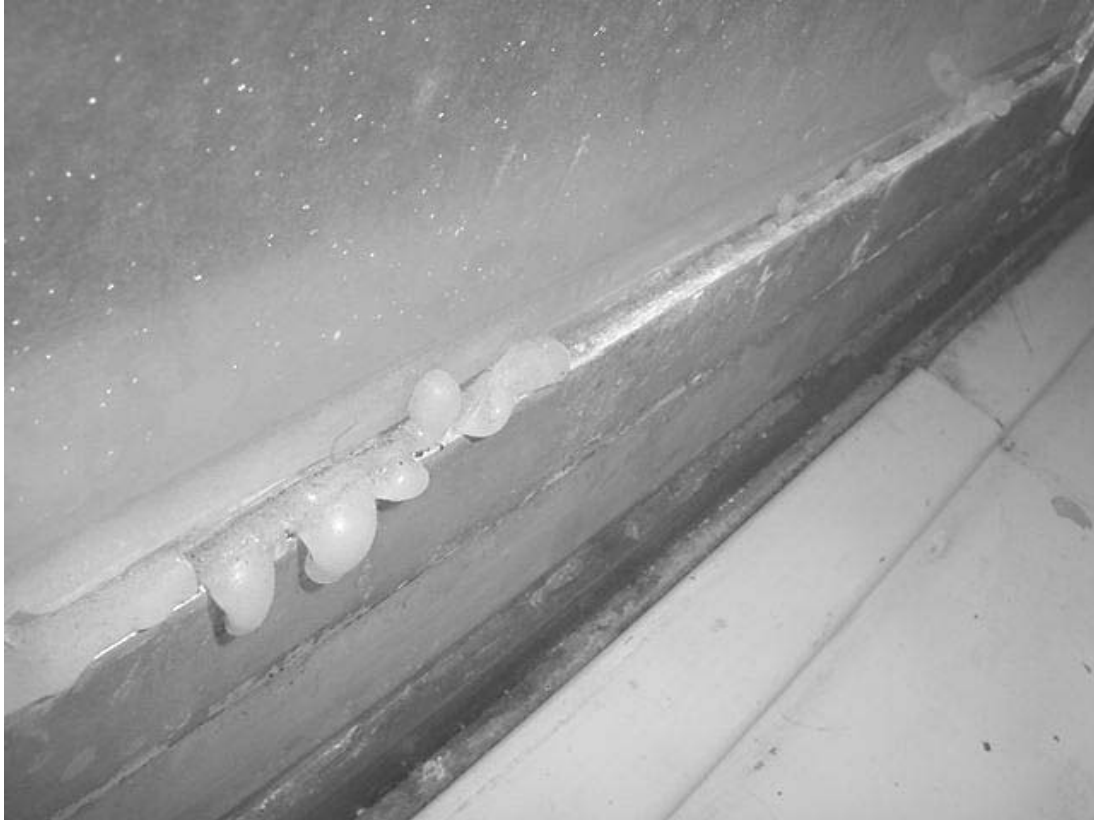
**Picture 7**

**Window Caulking Interior of Classroom, Note Incomplete/Irregular Pattern**

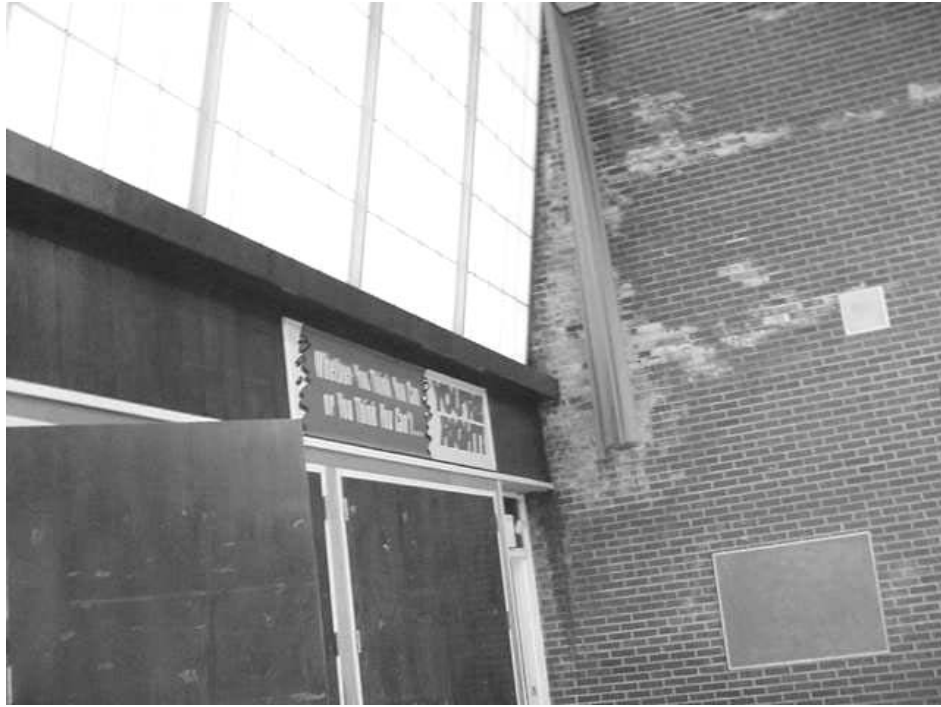
**Picture 8**

Efflorescence (i.e., mineral deposits) was observed in the cafeteria on brick walls (see Picture 8). Efflorescence is a characteristic sign of water damage to building materials such as brick or plaster, but it is not mold growth. As moisture penetrates and

works its way through mortar around brick, water-soluble compounds in bricks and mortar dissolve, creating a solution. As the solution moves to the surface of the brick or mortar, water evaporates, leaving behind white, powdery mineral deposits. This condition indicates that water from the exterior has penetrated into the building. In this case the most likely source of water penetration is the roof/skylight junction. School and town officials have contacted a number of roofing contractors and have been working to remediate the leak.

**Water Damage/Efflorescence on Wall Brick along Skylight Junction**

7. Continue working with roofing contractor to eliminate leaks in the gym/cafeteria. Replace any water-stained ceiling tiles and building materials. Examine the area above and around these areas for mold growth. Disinfect areas of water leaks with an appropriate antimicrobial.

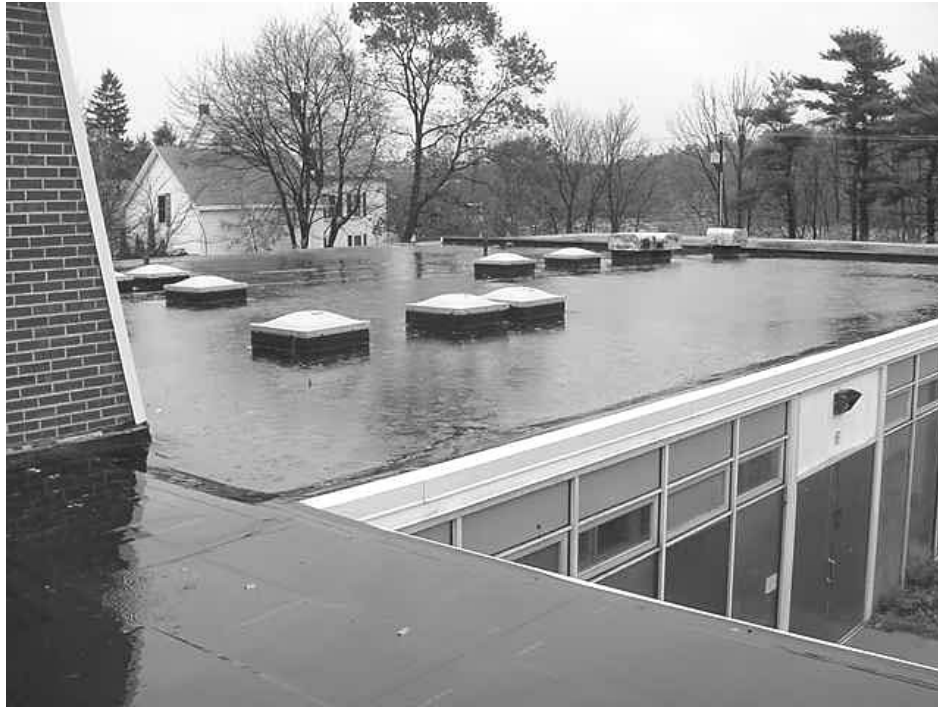
**Picture 9**

Pooling water was observed in a number of areas on the roof (see Picture 9). The freezing and thawing of water during winter months can lead to roof leaks and subsequent water penetration into the interior of the building. Pooling water can also become stagnant, which can lead to mold and bacterial growth, which can be introduced into the building by rooftop ventilation equipment. In addition, stagnant pools of water can serve as a breeding ground for mosquitoes.

**Pooling Water on Roof, Note the Majority of the Wing has Pooling Water**

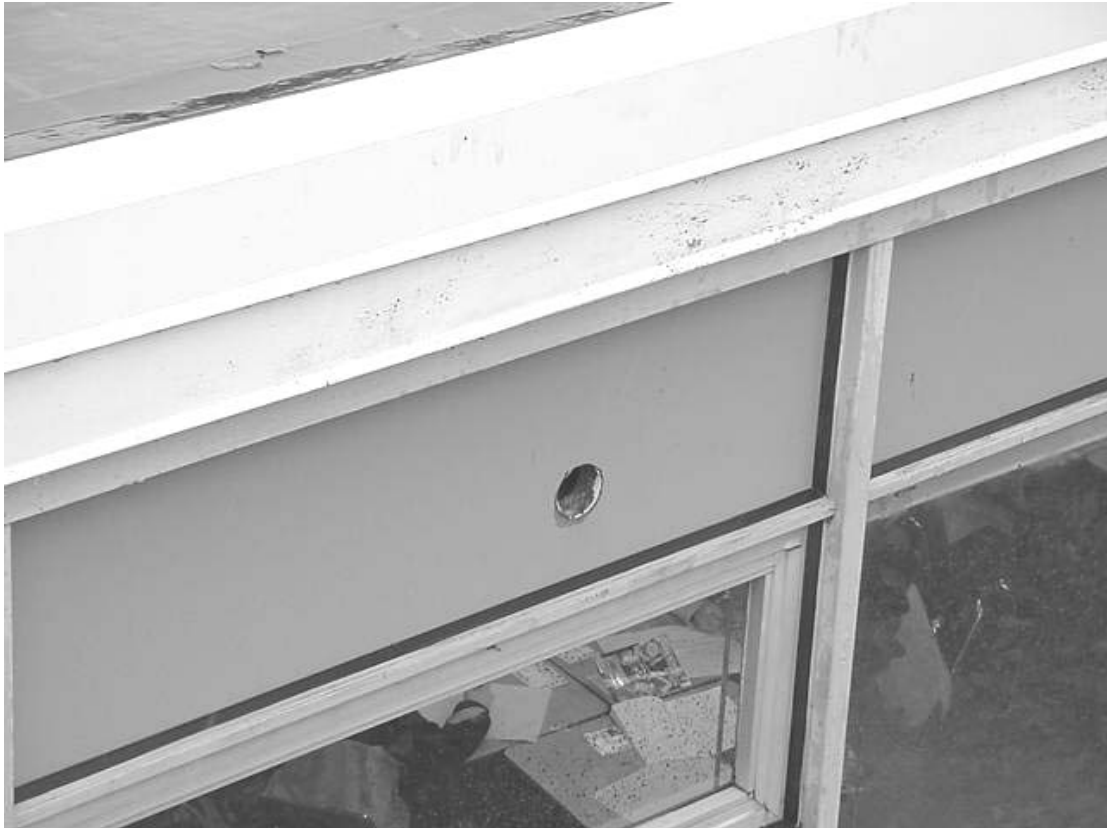
**Picture 10**

An open utility hole was observed in a wall/ceiling panel on the exterior of the building (see Picture 10). Breaches in the building envelope can provide a means for water/water vapor penetration into the building. Repeated water damage to porous building materials (e.g., wallboard, ceiling tiles, carpeting) can result in microbial growth. The American Conference of Governmental Industrial Hygienists (ACGIH) recommends that porous building materials be dried with fans and heating within 24

**Utility Hole in Side Panel of Building**

9. Replace wall panel or permanently seal open utility hole shown in Picture 10.
10. Store cleaning products properly and out of reach of students.
11. Relocate or consider reducing the amount of materials stored in classrooms to allow for more thorough cleaning. Clean items regularly with a wet cloth or sponge to prevent excessive dust build-up.

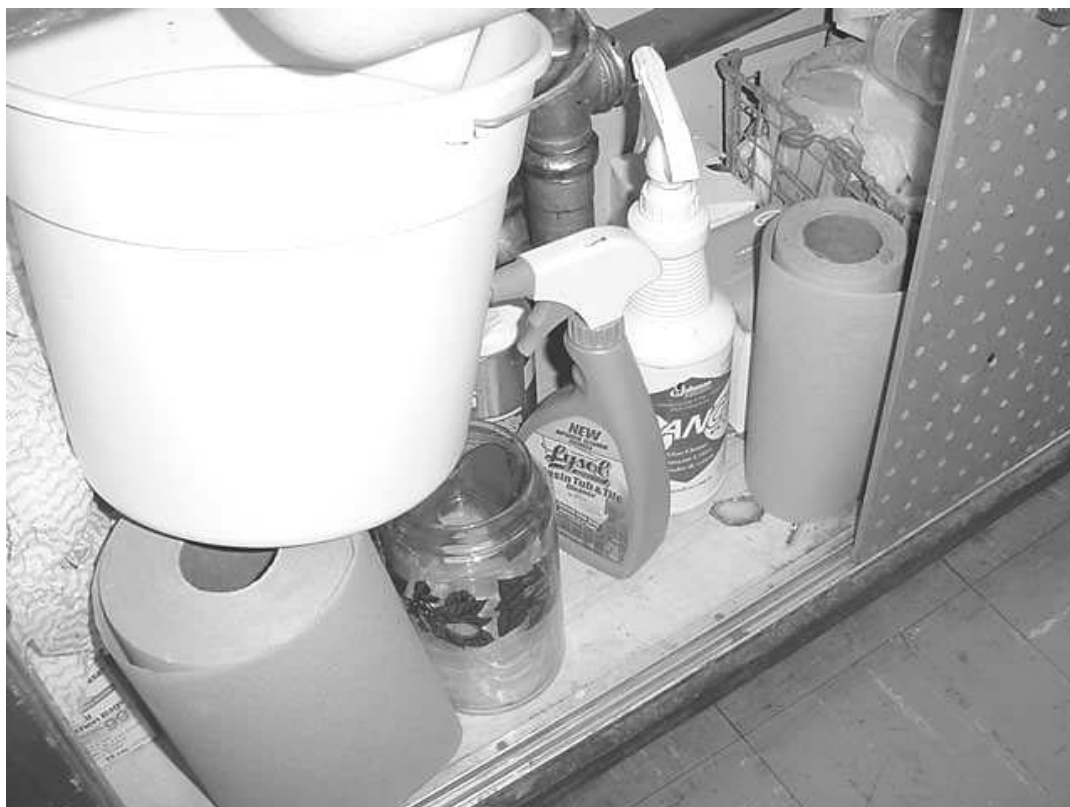
**Picture 11**

Cleaning products were found on countertops and beneath sinks in a number of classrooms (see Picture 11). Cleaning products contain chemicals, which can be irritating to the eyes, nose and throat and should be stored properly and kept out of reach of students.

**Spray Cleaning Products beneath Classroom Sink**

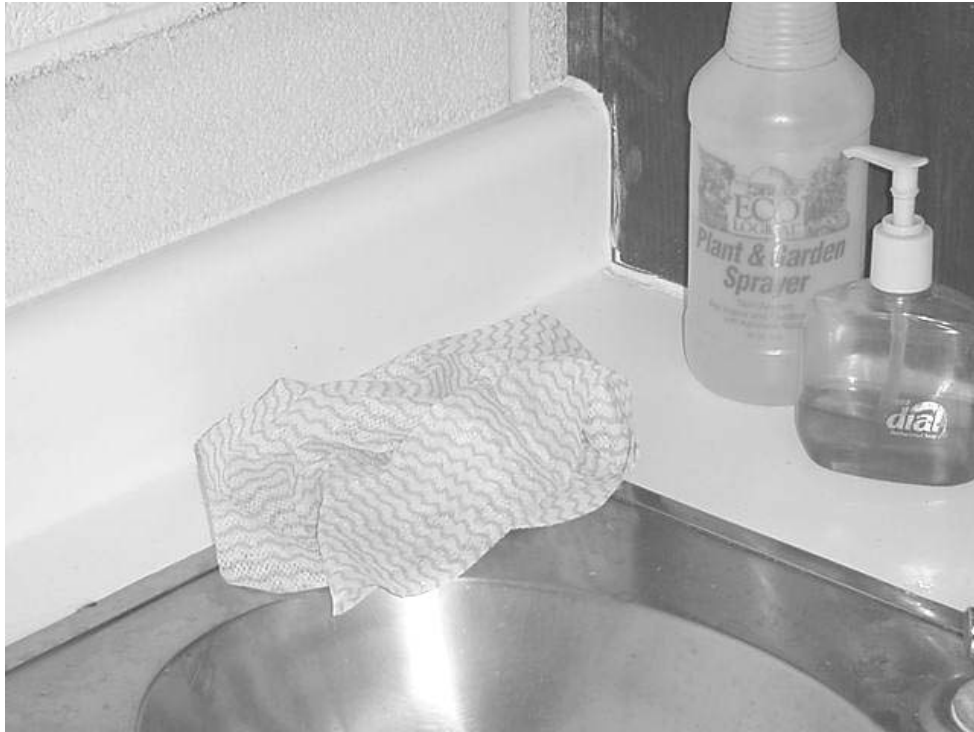
**Picture 12**

**One-Piece Molded Countertop**

8. Seal areas around sinks to prevent water-damage to the interior of cabinets and adjacent wallboard. Inspect wallboard for water-damage and mold/mildew growth, repair/replace as necessary. Disinfect areas of microbial growth with an appropriate antimicrobial as needed. Consider replacing with one-piece, molded countertops as shown in Picture 12.
